DEPARTMENT OF TRANSPORTATION**DIVISION OF ENGINEERING SERVICES**

Contract #: 04-0120F4Cty: SF/ALA Rte: 80 PM: 13.2/13.9File #: 69.28**WELDING INSPECTION REPORT****Resident Engineer:** Pursell, Gary**Address:** 333 Burma Road**City:** Oakland, CA 94607**Report No:** WIR-012931**Date Inspected:** 07-Apr-2010**Project Name:** SAS Superstructure**OSM Arrival Time:** 700**Prime Contractor:** American Bridge/Fluor Enterprises, a JV**OSM Departure Time:** 1900**Contractor:** Zhenhua Port Machinery Company, Ltd (ZPMC), Changxing Island **Location:** Shanghai, China**CWI Name:** Li Yang**CWI Present:** Yes No**Inspected CWI report:** Yes No N/A**Rod Oven in Use:** Yes No N/A**Electrode to specification:** Yes No N/A**Weld Procedures Followed:** Yes No N/A**Qualified Welders:** Yes No N/A**Verified Joint Fit-up:** Yes No N/A**Approved Drawings:** Yes No N/A**Approved WPS:** Yes No N/A**Delayed / Cancelled:** Yes No N/A**Bridge No:** 34-0006**Component:** OBG**Summary of Items Observed:**

OUTSIDE YARD**ULTRASONIC INSPECTION****OBG 9CE**

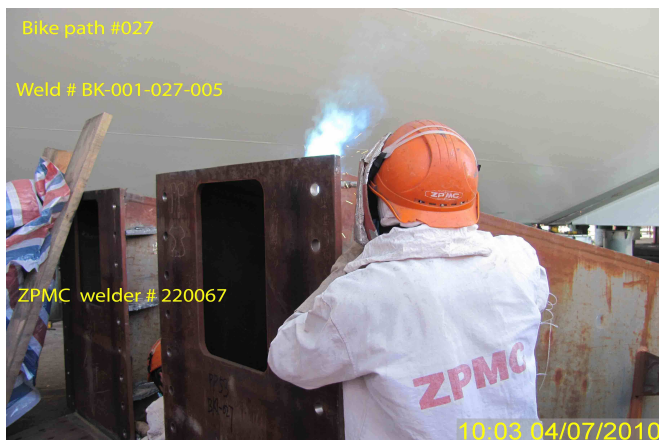
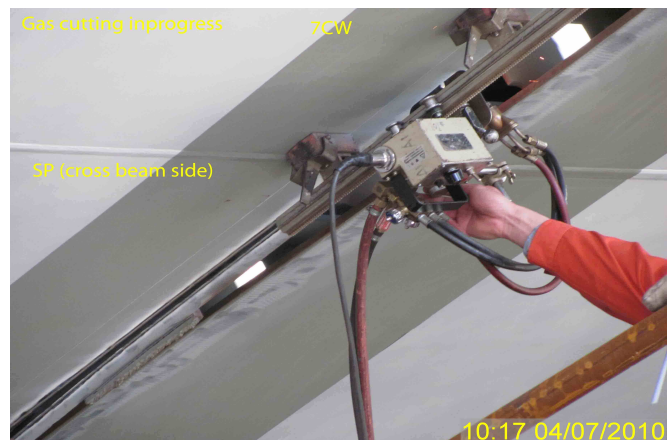
Unless otherwise noted, all work observed on this dated appeared to generally comply with applicable contract documents.
